North Bank Playground

Completed By: Patrick McCord

Date of Report: June 18, 2020

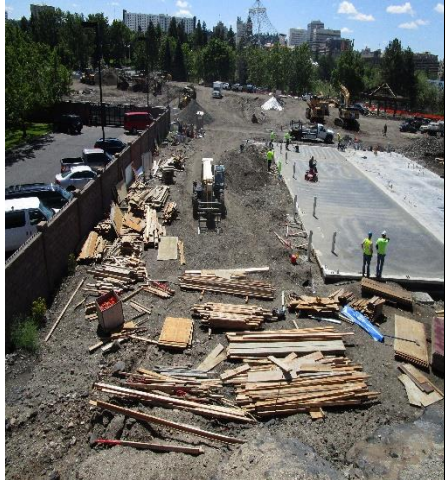
#1 View from cliff east side of the cliff (facing south).

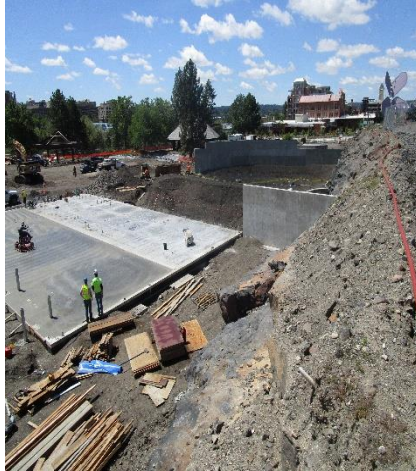
#2 View from east side of the cliff (facing west).

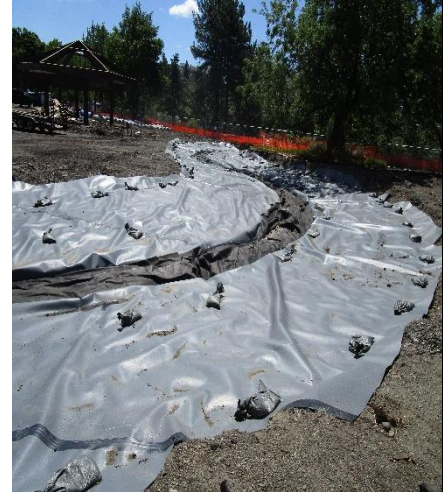
#3 Storm channel liner/membrane and piping.

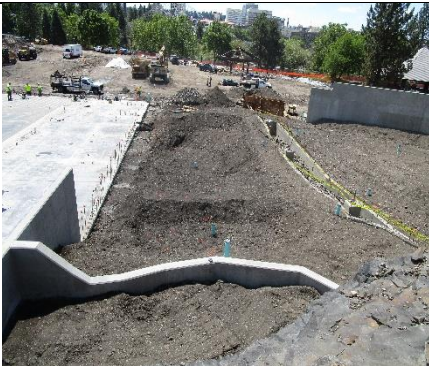
#4 East section of skate park.

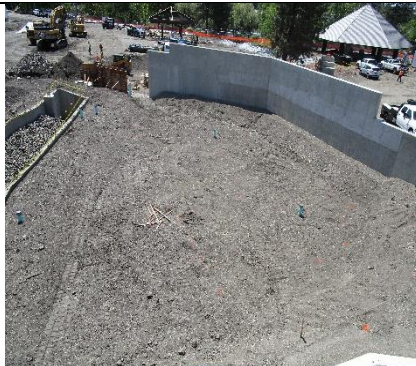
#5 West section of skate park.

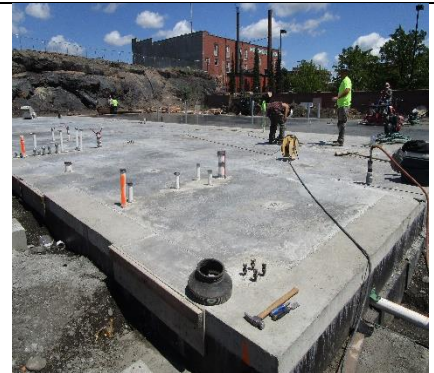
#6 M&O Building foundation (view from southwest corner)

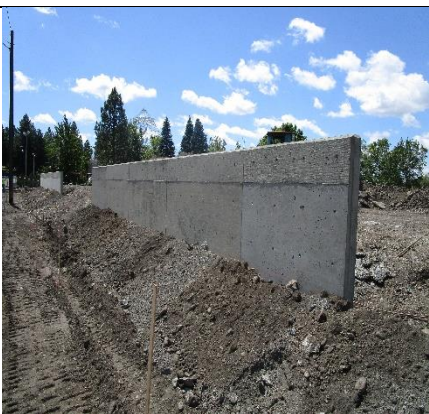
7 East side site retaining walls.

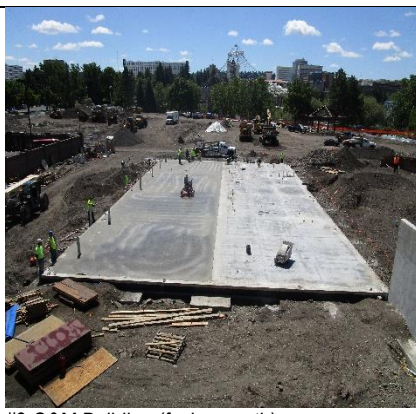
#8 O&M Building (facing south).

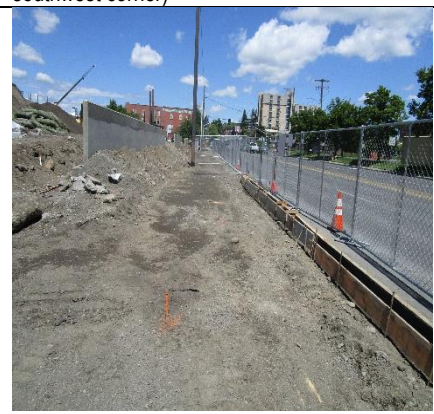
#9 Sidewalk subgrade along Washington Street.
